## INSPECTION REPORT

#### ROLLINS OIL PROCESS COMPANY (OPC)

Inspected by: Guillermo Hernandez Hazardous Materials Specialist

Date of Inspection: December 2, 1992

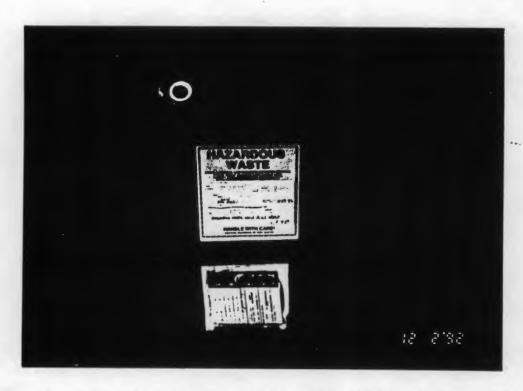
Photo No.: 1 Date: December 2, 1992 Inspector: G. Hernandez

At the shipping and receiving area, we observed 4 roll-off bins identified as containing hazardous waste with no hazardous characteristic. The four roll off bins were identified as containing crushed drums (See Attachment B, Photos # 1,2,3,4).

OPC failed to properly mark or label 50 containers, in that four roll-off bins containing hazardous waste in the shipping and receiving area and forty three 55 gallon drums of "F" and "D" series waste and three 55 gallon drums of elemental mercury at the storage area failed to include the following information:

<u>Description</u> One roll-off bin at the shipping and receiving area, identified as hazardous waste and containing crushed drums was observed to be improperly labeled. Photo taken by Kou.

- 1. We have installed a mechanism to assure that our hazardous waste labels are printed correctly, and all the hazard properties are indicated. When the waste is a combination of several wastes with different properties, a combination of these properties will be indicated.
- 2. All inspections logs that did not specify time of the inspection have been revised to indicate the time of the inspection. Also added is when corrective action is completed if corrective action is required as a result of inspection.
- 3. Our contingency plan has been revised to indicated street address for all emergency coordinator.

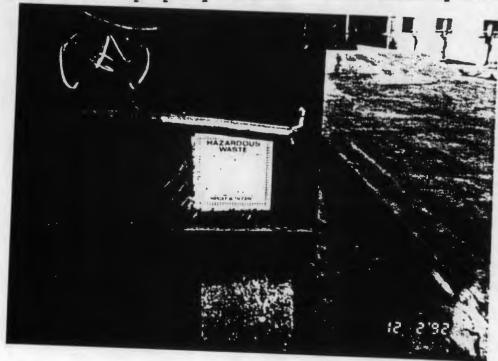
Photo No.: 2 Date: December 2, 1992 Inspector: G. Hernandez

<u>Description</u> One roll-off bin in the shipping and receiving area, identified as hazardous waste and containing crushed drums was observed to be improperly labeled. Photo taken by Kou.

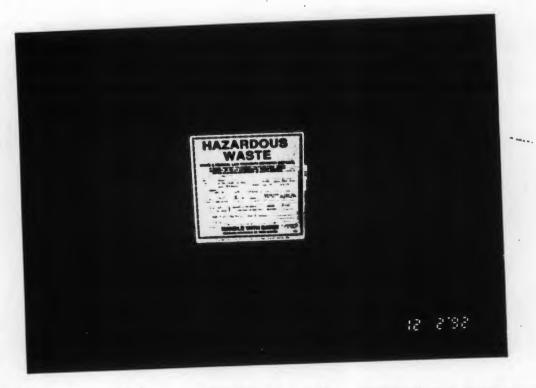
Photo No.: 3 Date: December 2, 1992 Inspector: G.Hernandez

<u>Description</u> Photo of roll-off bin at the shipping and receiving area, identified as hazardous waste and containing crushed drums was observed to be improperly labeled. Photo taken by Kou.

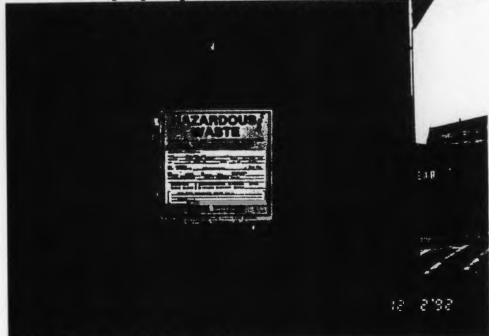
Photo No.: 4 Date: February 15, 1991 Inspector: G.Hernandez

<u>Description</u> Photo of one roll-off bin at the shipping and receiving area identified as hazardous waste and containing crushed drums was observed to be improperly labeled. Photo taken by Kou.

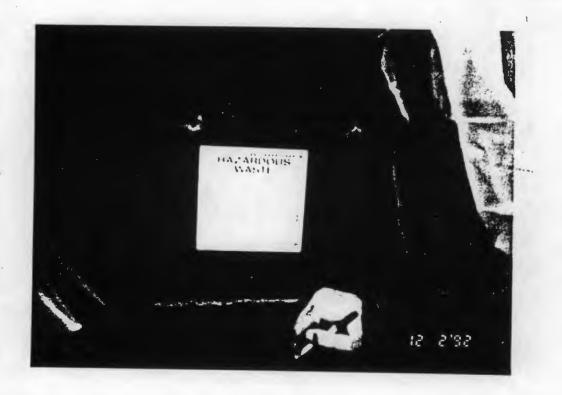
Photo No.: 5 Date: December 2, 1992 Inspector: G. Hernandez

We than proceeded to the filter press area and looked at the roll-off bin where the collection of filter cake occurs. The 20 cubic yard roll-off bin did not state the hazardous characteristic and was identified by OPC as containing hazardous waste (See Attachment B, Photo #5).

<u>Description</u> Photo of one roll-off bin at the filter press area identified as hazardous waste and containing filter cake was observed to be improperly labeled. Photo taken by Kou.

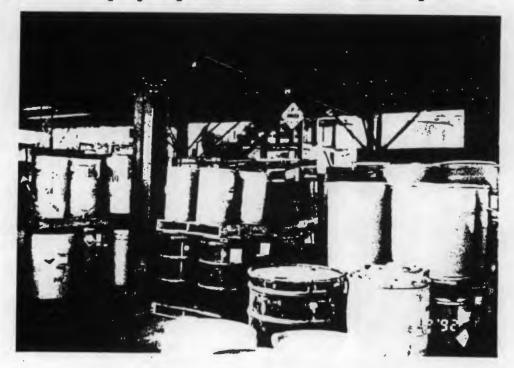
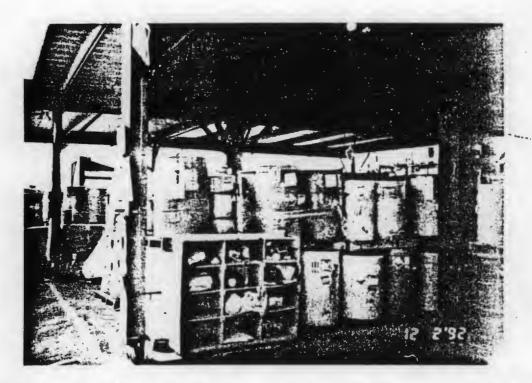
At the storage area, we observed that waste streams are segregated into several bays. The bays are segregated from letters "A" through "G" (See Attachment B, Photos # 6 & 7). Bay "A" is where flammable liquids and solids are stored and where repackaging occurs. Bays "B"and "C" store corrosive liquids and solids, bays "D" and "E" store oxidized liquids and solids and bays "F" and "G" store poison liquids and solids. During our walk-through we observed that several drums containing "F" and "D" series wastes had the marking of "other" when identifying a hazardous characteristic. informed Ndubuizu that the containers must identified one of the criteria identified in Title 22. The drums contained one of the following wastes: F001, F002, F003, F005 or D018, D019 D021, D039 and D041. We identified forty three 55 gallon drums improperly identifying the hazardous characteristic (See Attachment B, Photos # 8, 9, 10 & 11). We also observed one 5 gallon container containing Phenol Chloroform improperly closed. The container was marked "poison" and was identified by Ndubuizu as containing hazardous waste (See Attachment B, Photo # 12).

<u>Photo No.:</u> 6 <u>Date:</u> December 2, 1992 <u>Inspector:</u> G. Hernandez <u>Description</u> Photo of storage area, where waste streams are segregated into several bays. Photo taken by Kou.

<u>Photo No.:</u> 7 <u>Date:</u> December 2, 1992 <u>Inspector:</u> G. Hernandez <u>Description</u> Photo of storage area, were waste streams are segregated into several bays. Photo taken by Kou.

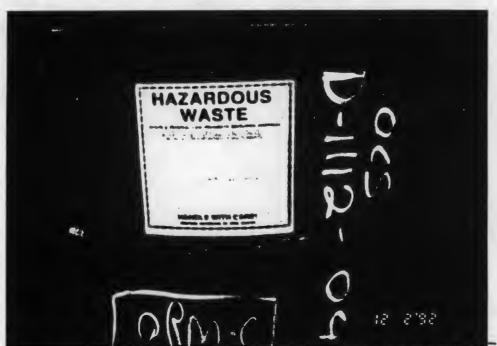
Photo No.: 8 Date: December 2, 1992 Inspector: G. Hernandez

<u>Description</u> Photo of one 55 gallon drum identified as containing "D" series hazardous wastes observed to have no hazardous characteristic. Photo taken by Kou at the storage area.

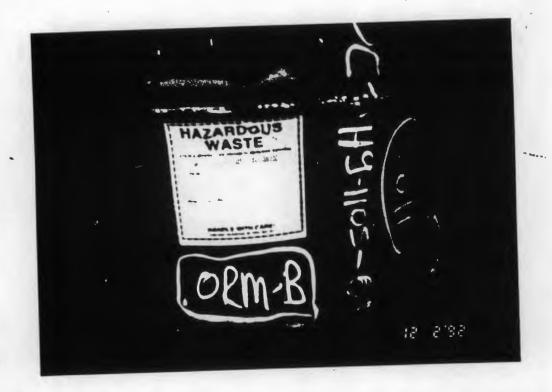
Photo No.: 9 Date: December 2, 1992 Inspector: G. Hernandez

<u>Description</u> Photo of one 55 gallon drum containing "D" series hazardous waste observed to have no hazardous characteristics.

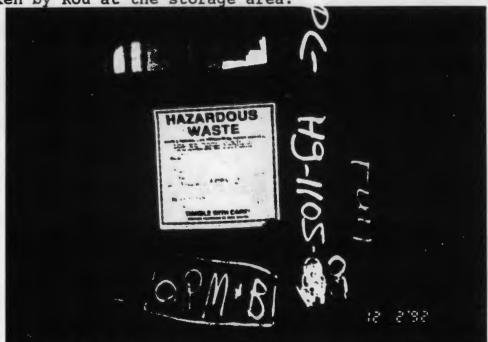
Photo No.: 10 Date: December 2, 1992 Inspector: G. Hernandez

<u>Description</u> Photo of one 55 gallon drum identified as containing "D" series hazardous waste observed to have no hazardous characteristics. Photo taken by Kou at the storage area.

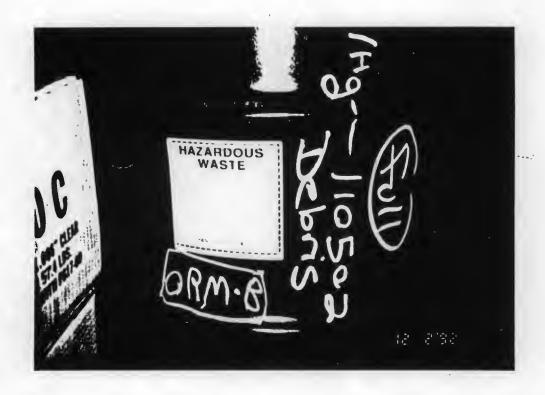
Photo No.: 11 Date: December 2, 1992 Inspector: G. Hernandez

<u>Description</u> Photo of one 55 gallon drum containing "D" series hazardous waste observed to have no hazardous characteristic. Photo taken by Kou at the storage area.

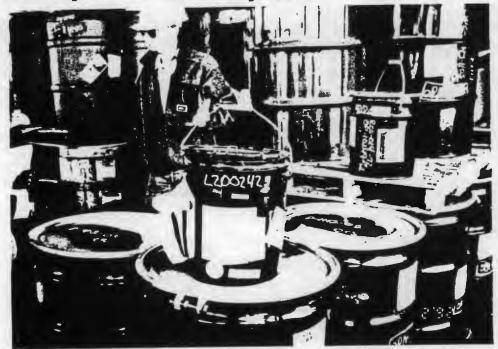
Photo No.: 12 Date: December 2, 1992 Inspector: G. Hernandez

OPC failed to always keep a container holding hazardous waste closed at all times, in that one 5 gallon container of poison phenol chloroform was observed to be improperly closed.

Evidence: Ndubuizu identified the 5 gallon container of phenol chloroform as hazardous waste. See Attachment B, Photo # 12.

<u>Description</u> Photo of one 5 gallon container of phenol chloroform observed to be improperly closed. Photo taken by Kou at the storage area.

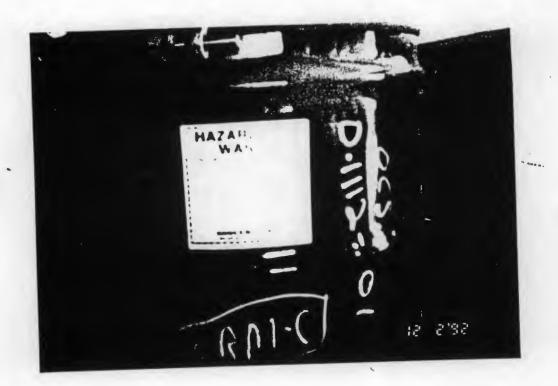
Photo No.: 13 Date: December 2, 1992 Inspector: G. Hernandez

Three 55 gallon drums of elemental mercury was also observed to have no hazardous characteristic in the storage area. We informed Ndubuizu again that these drums were also improperly labeled, he agreed and stated that it would be corrected immediately (See Attachment B, Photo #'s 13, 14 & 15).

<u>Description</u> Photo of one 55 gallon drum identified as hazardous waste containing elemental mercury observed with no hazardous characteristic. Photo taken by Kou at the storage area.

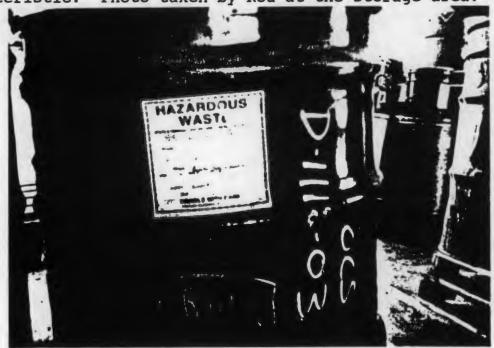
Photo No.: 14 Date: December 2, 1992 Inspector: G. Hernandez

<u>Description</u> Photo of one 55 gallon drum identified as hazardous waste containing elemental mercury observed with no hazardous characteristic. Photo taken by Kou at the storage area.

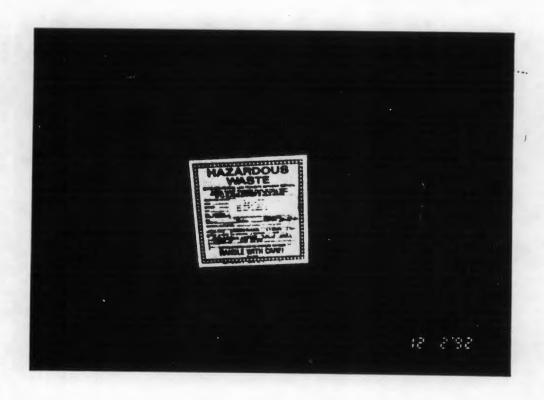
Photo No.: 15 Date: December 2, 1992 Inspector: G. Hernandez

<u>Description</u> Photo of one 55 gallon drum identified as hazardous waste containing elemental mercury observed with no hazardous characteristic. Photo taken by Kou at the storage area.
